**[Docket No. FAA-2010-1101; Directorate Identifier 2009-CE-013-AD; Amendment 39-16690; AD 2011-10-09]**

**Airworthiness Directives; Cessna Aircraft Company Models 150, 152, 170, 172, 175, 177, 180, 182, 185, 188, 190, 195, 206, 207, 210, T303, 336, and 337 Airplanes**

**ACTION:** Final rule.

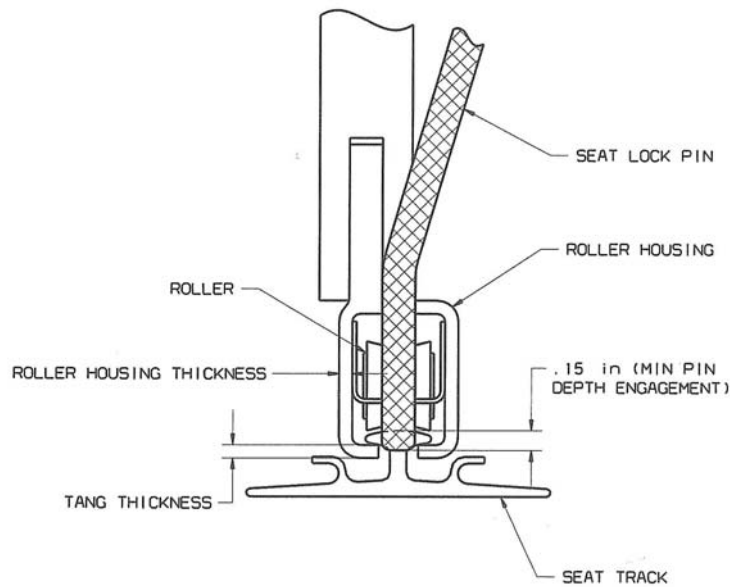
Figure 2. Seat locking pin depth engagement

(5) Inspect the thickness of the tang (see figure 2 and figure 3). Due to wear of the tang chafing against the seat rail, measure the tang thickness where the tang inner edges contact the seat rail.

(10) Lift up the forward edge of each seat to eliminate vertical play of the seat locking pin in the engagement hole, and from this position, inspect the depth of engagement of each seat locking pin (see figure 2). If the rail is worn, this depth is measured from the worn surface, not the manufactured surface.

(i) If engagement of any of the seat locking pins measures less than 0.15 of an inch, before further flight, replace or repair any seat components necessary to achieve a seat pin engagement of a minimum of 0.15 of an inch.
